Manhole Inspection Summary

Manhole # S25C1_008MH

Location Address: **2344 ANNAPOLIS RD.**

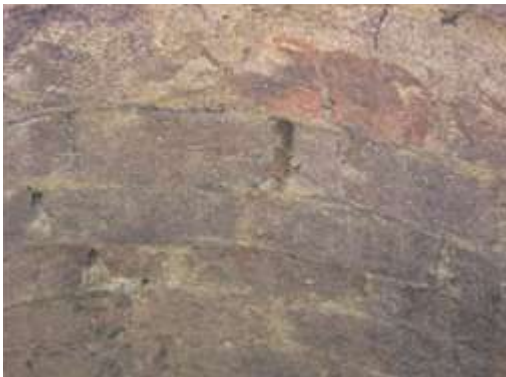
Defect 3

Infiltration: ☐ None ☐ Joint ☐ Cracks ☒ **Mortar** ☐ Roots ☐ Wall

MISSING MORTAR AT THE CORBEL

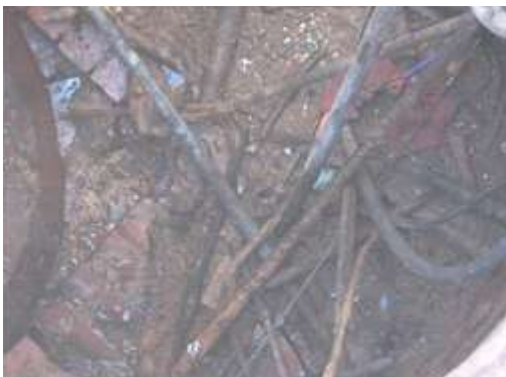
Defect 1

Condition: ☐ Sound ☐ Cracked ☐ Root Intrusion ☐ Deteriorated ☐ Leaks ☒ **Debris**

DEBRIS ON THE BENCH

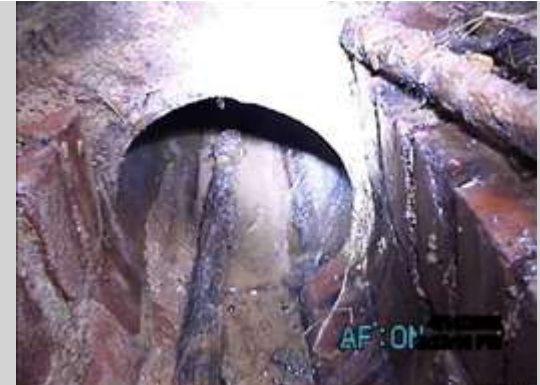
12 O'Clock Outflow

Pipe Height: **8.4** (in.) Rod and Bar (Angled)
Pipe Material: **Clay** ☐ Pipe Lined
Invert Depth: **6.21** (ft.) Flow Characteristics: **None**
Deposits: ☐ None ☐ Mud ☐ Sludge ☒ **Debris** ☐ Grease
Silt Depth: **0** (in.) Deposits Extent: **Medium**
Infiltration: **Evidence** Pipe Seal Cond: **Sound**
